Manhole Inspection Summary

Manhole # S11MM_040MH

Insp Date: **8/29/07 5:02 PM**

Location Address: **WINDSOR AVE ALLEY**

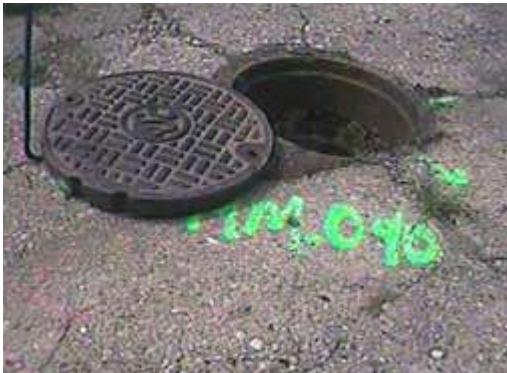
Location View

MISSING RUNG

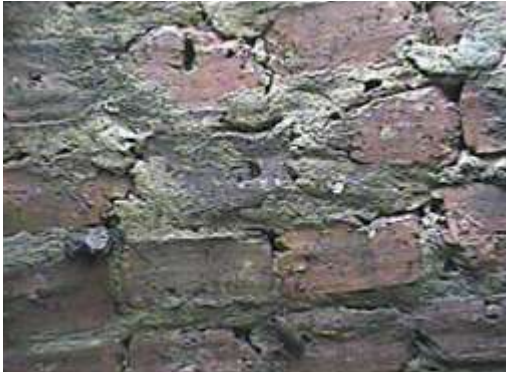
Defect 1

Steps Count: **3** Missing: **1** ☒ **Corroded**

MISSING RUNG

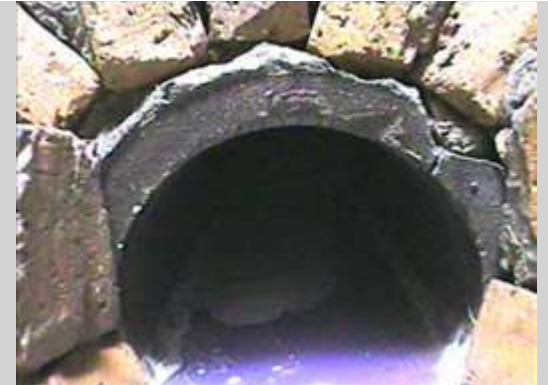
12 O'Clock Outflow

8 in. Circular Gravity Sewer
Pipe Out @ 12 O'Clock

MISSING RUNG

Infiltration: **None** Pipe Seal Cond: **Cracked**

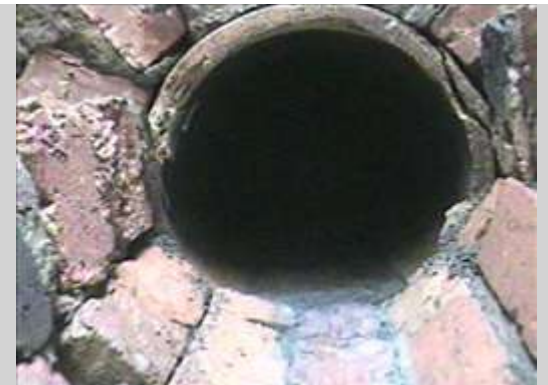
3 O'Clock Inflow

8 in. Circular Gravity Sewer
Pipe In @ 3 O'Clock

Infiltration: **None** Pipe Seal Cond: **Cracked**

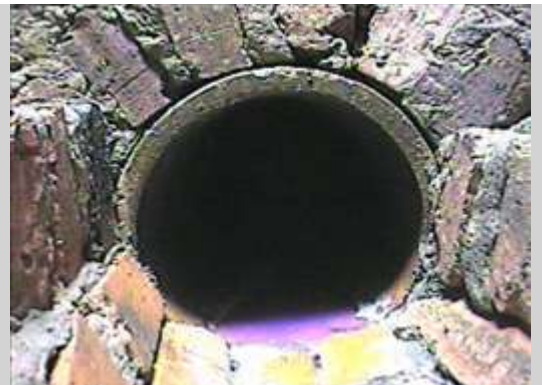
9 O'Clock Inflow

8 in. Circular Gravity Sewer

Pipe In @ 9 O'Clock

Infiltration: **None** Pipe Seal Cond: **Sound**
